STATUS OF THE LAO CAI-HANOI  
AND PING HSIANG-HANOI  
RAILROAD LINES

CIA/PIR 65024

DATE August 1965

LAO CAI-HANOI RAILROAD BOMB DAMAGE ASSESSMENT

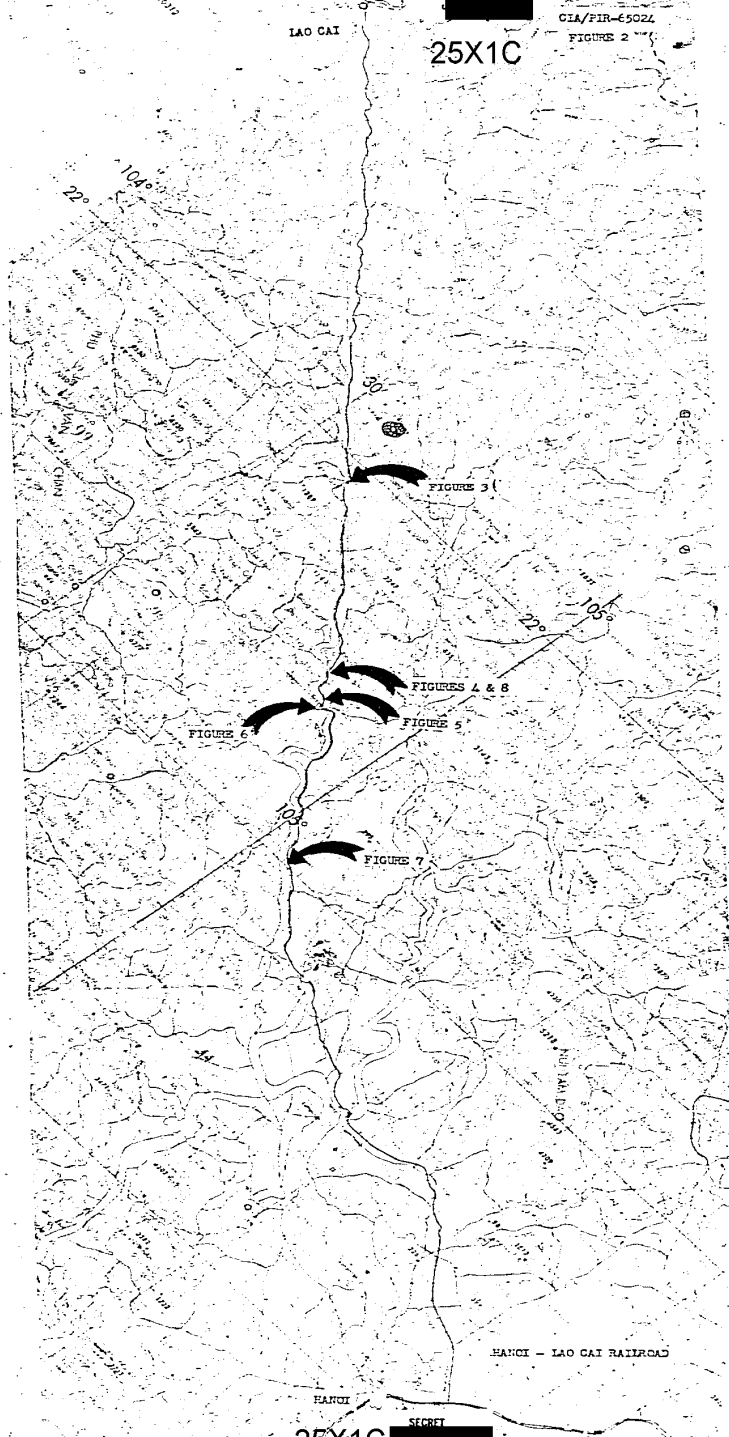
FIGURE 2

HANOI - LAO CAI RAILROAD
